# **A Brief Report on Pen y Bryn and Aber, Gwynedd**

**by Paul Martin Remfry**

2012

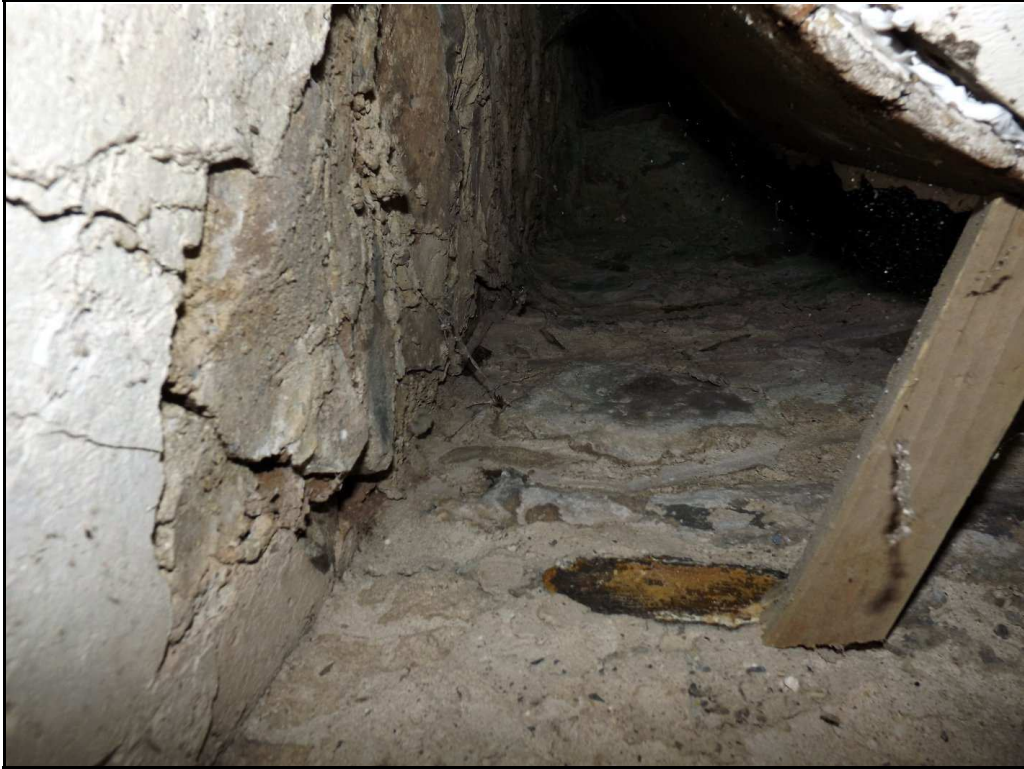
**Figure 39**, The blocking wall in the passageway in the south-west corner of the house (H) to the left. The tower (T) wall is to the bottom right and the back of the fitted cupboard to the top right.

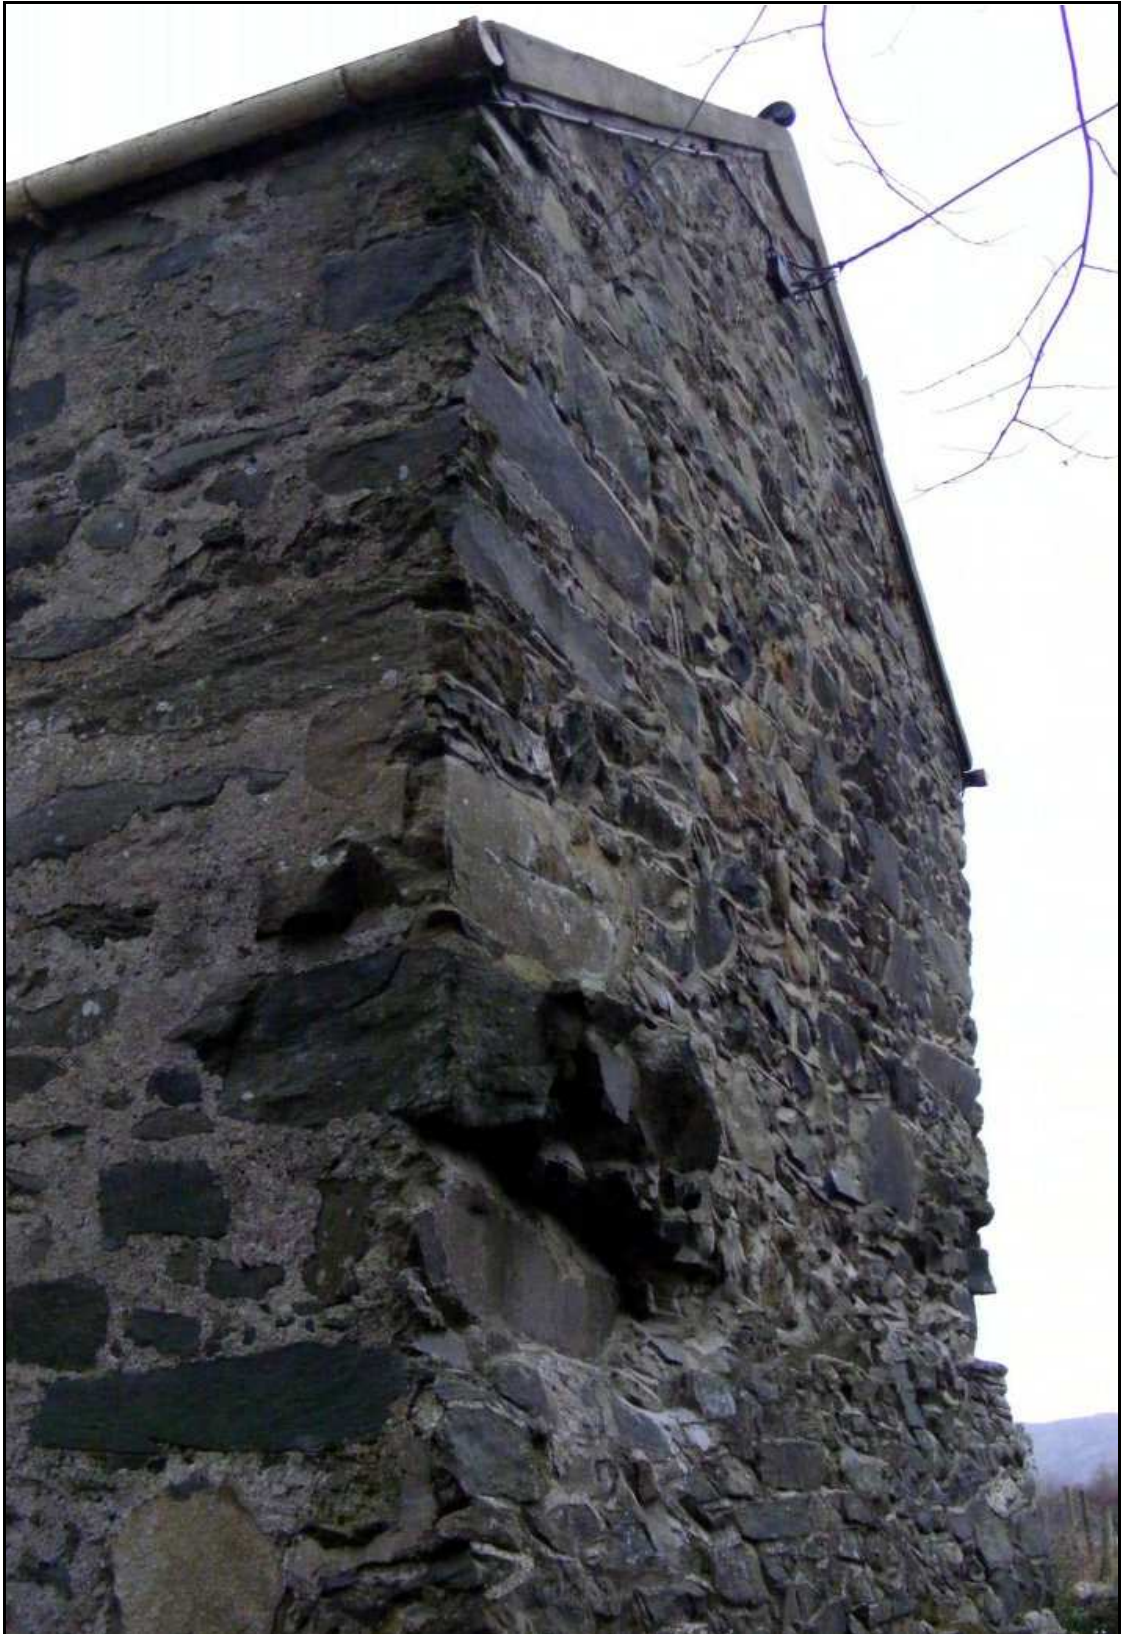
**Figure 43**, The southern end of the south range (S), showing the line of the projecting first floor level and the large, replaced corner quoins above. The top of the added sloping plinth can be made out at the bottom of the picture.

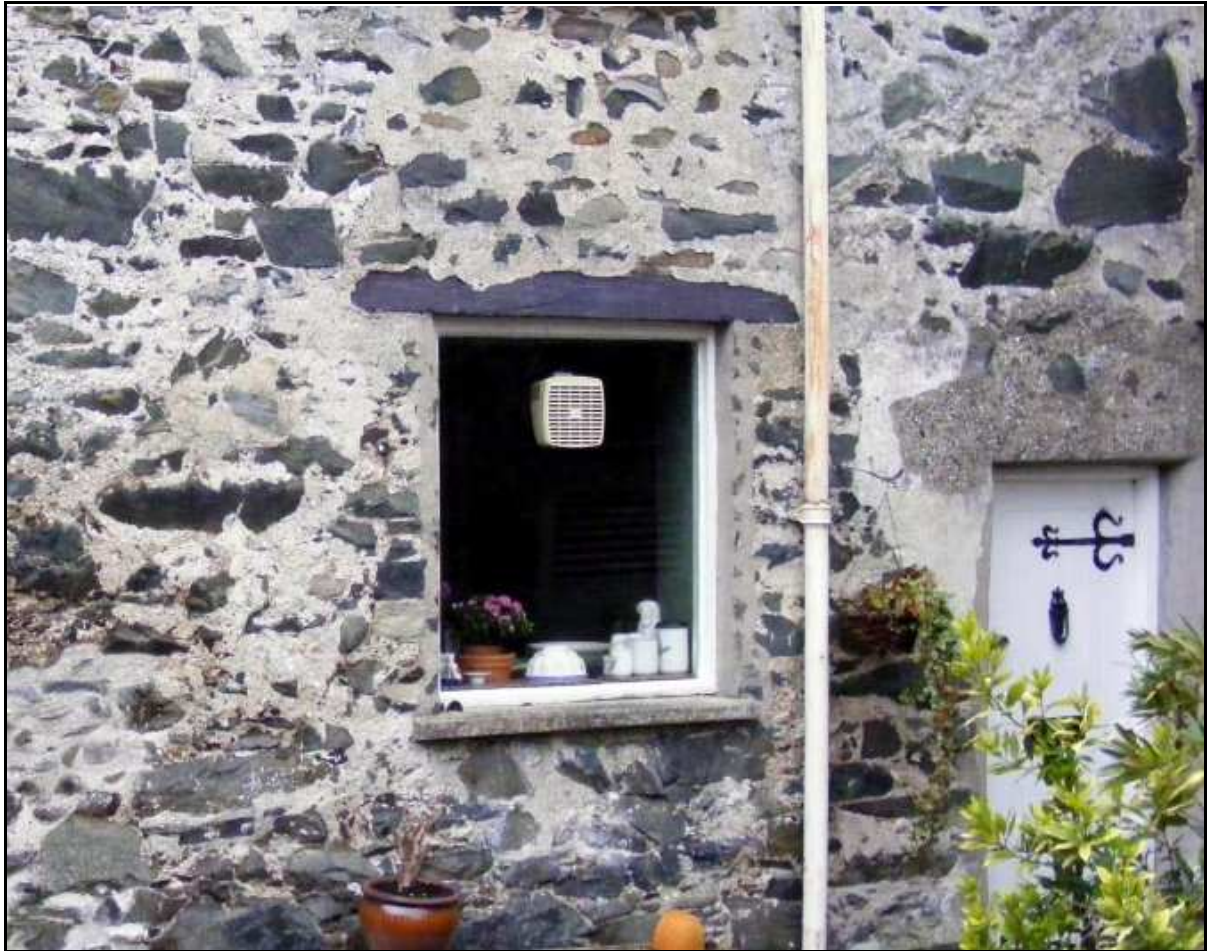
**Figure 46**, The eastern window of the south range (S) showing its slate lintel and much rubble packing underneath and on either side which consists of smaller pieces of stone than the rest of the wall. The modern door to the north has a concrete lintel.

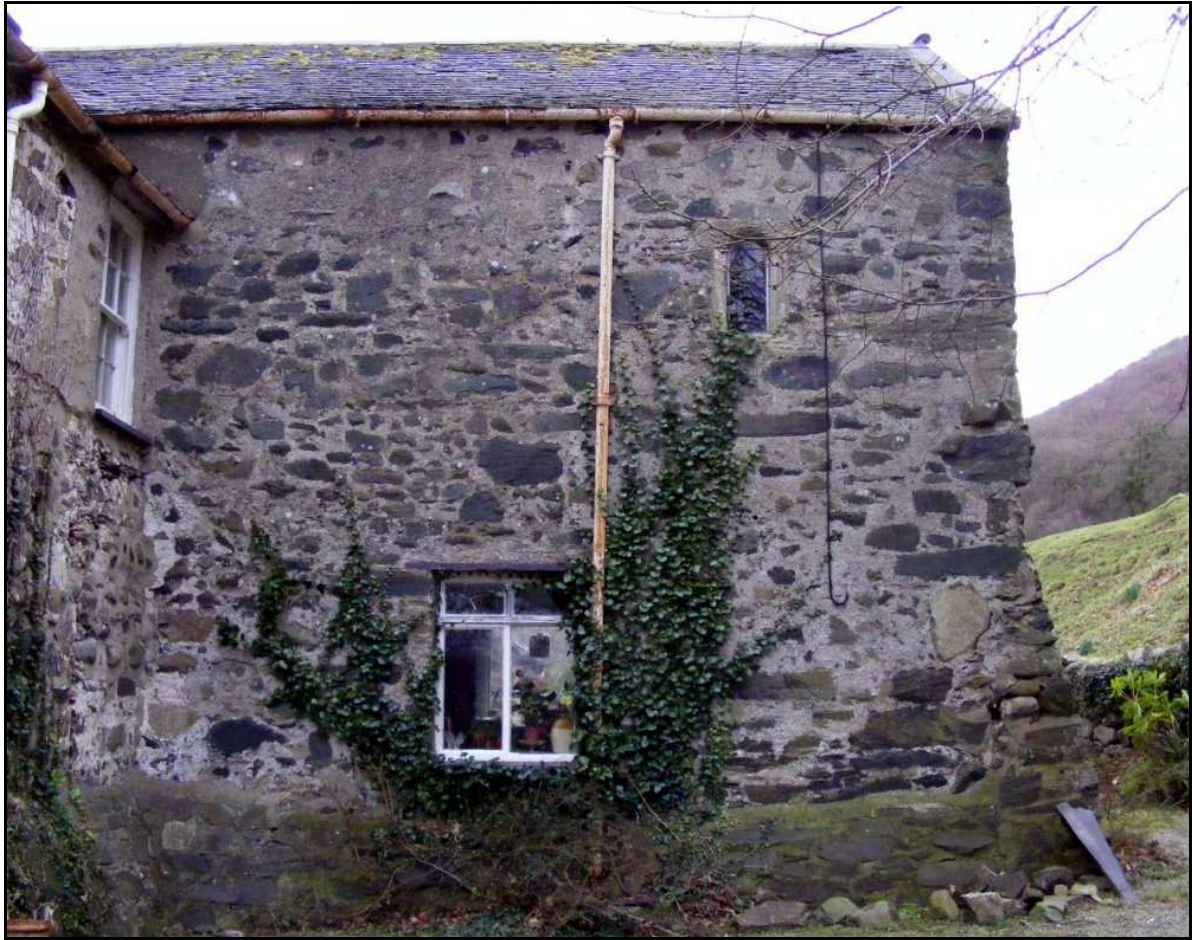
**Figure 47**, The site of what may possibly be a blocked window in the southern end of the eastern wall of the south range (S).

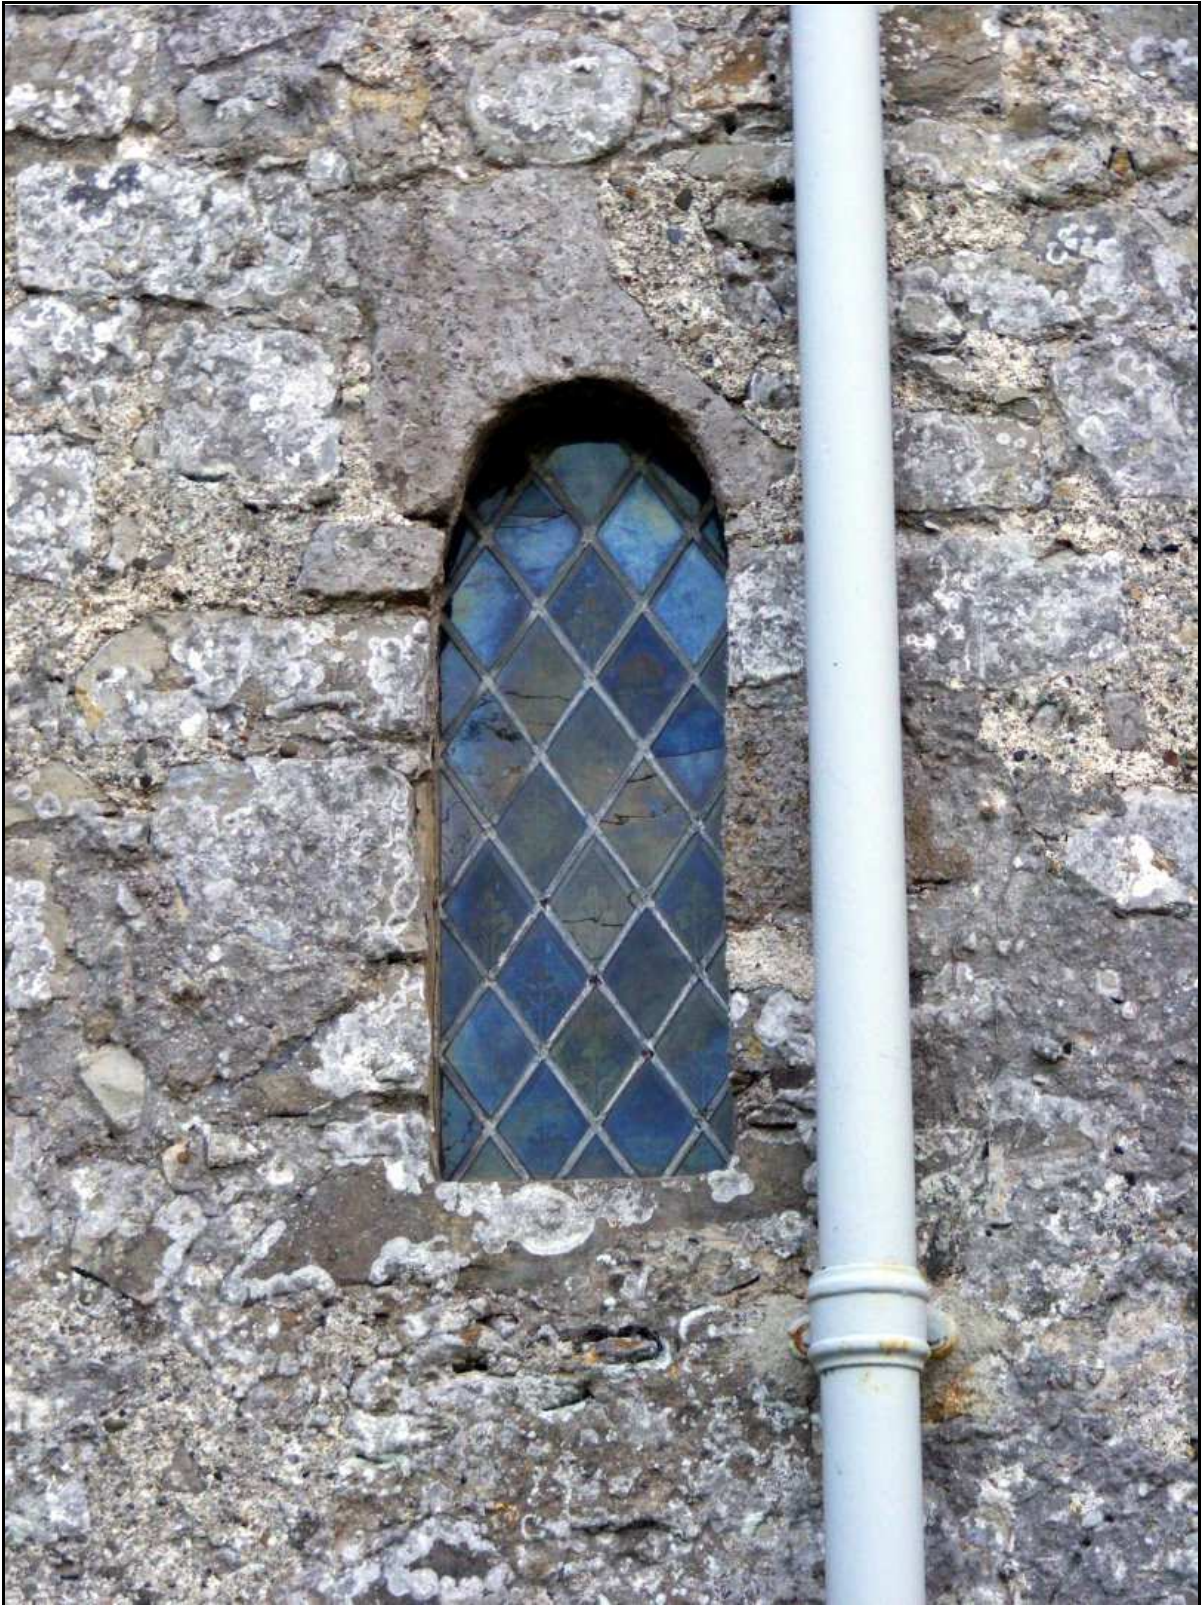
**Figure 50**, The arched window in the west wall of the upper storey of the south range (S). Note the decoration.

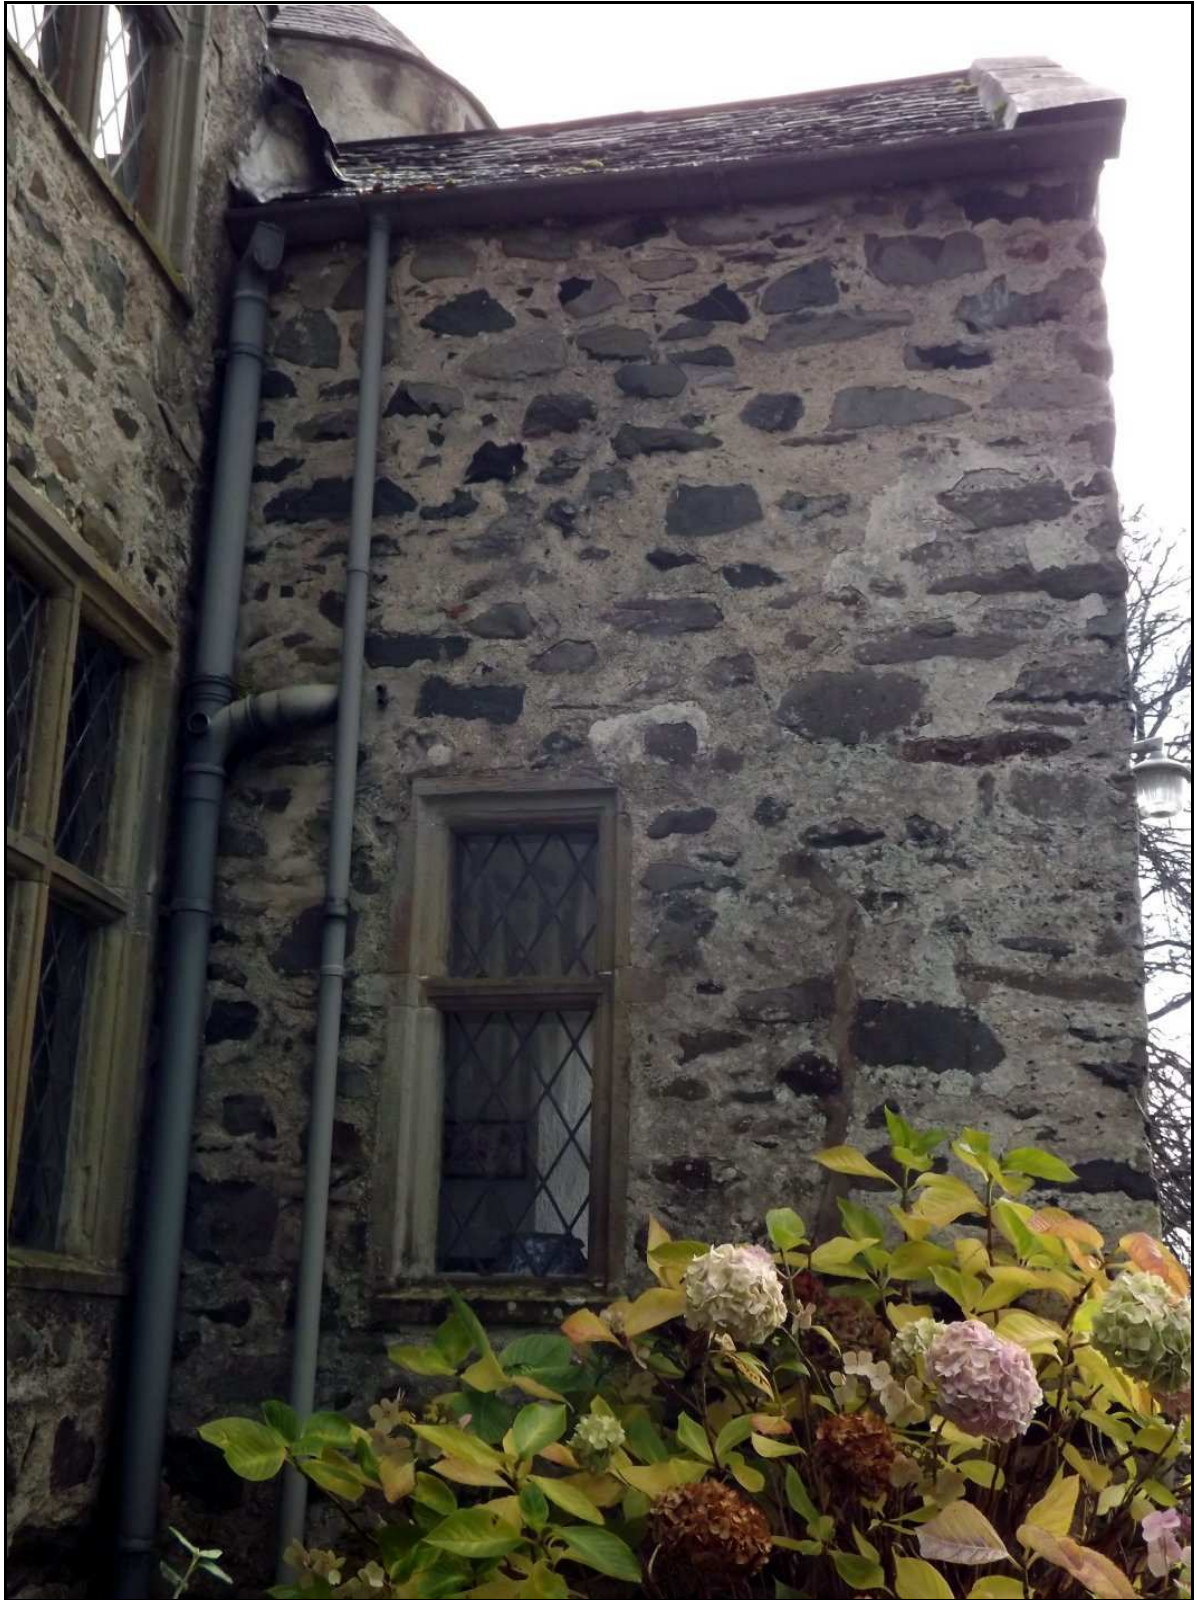
**Figure 55**, The east side of the porch (P) showing the fracture line between the replaced corner of the building for the lower three-quarters of its height,

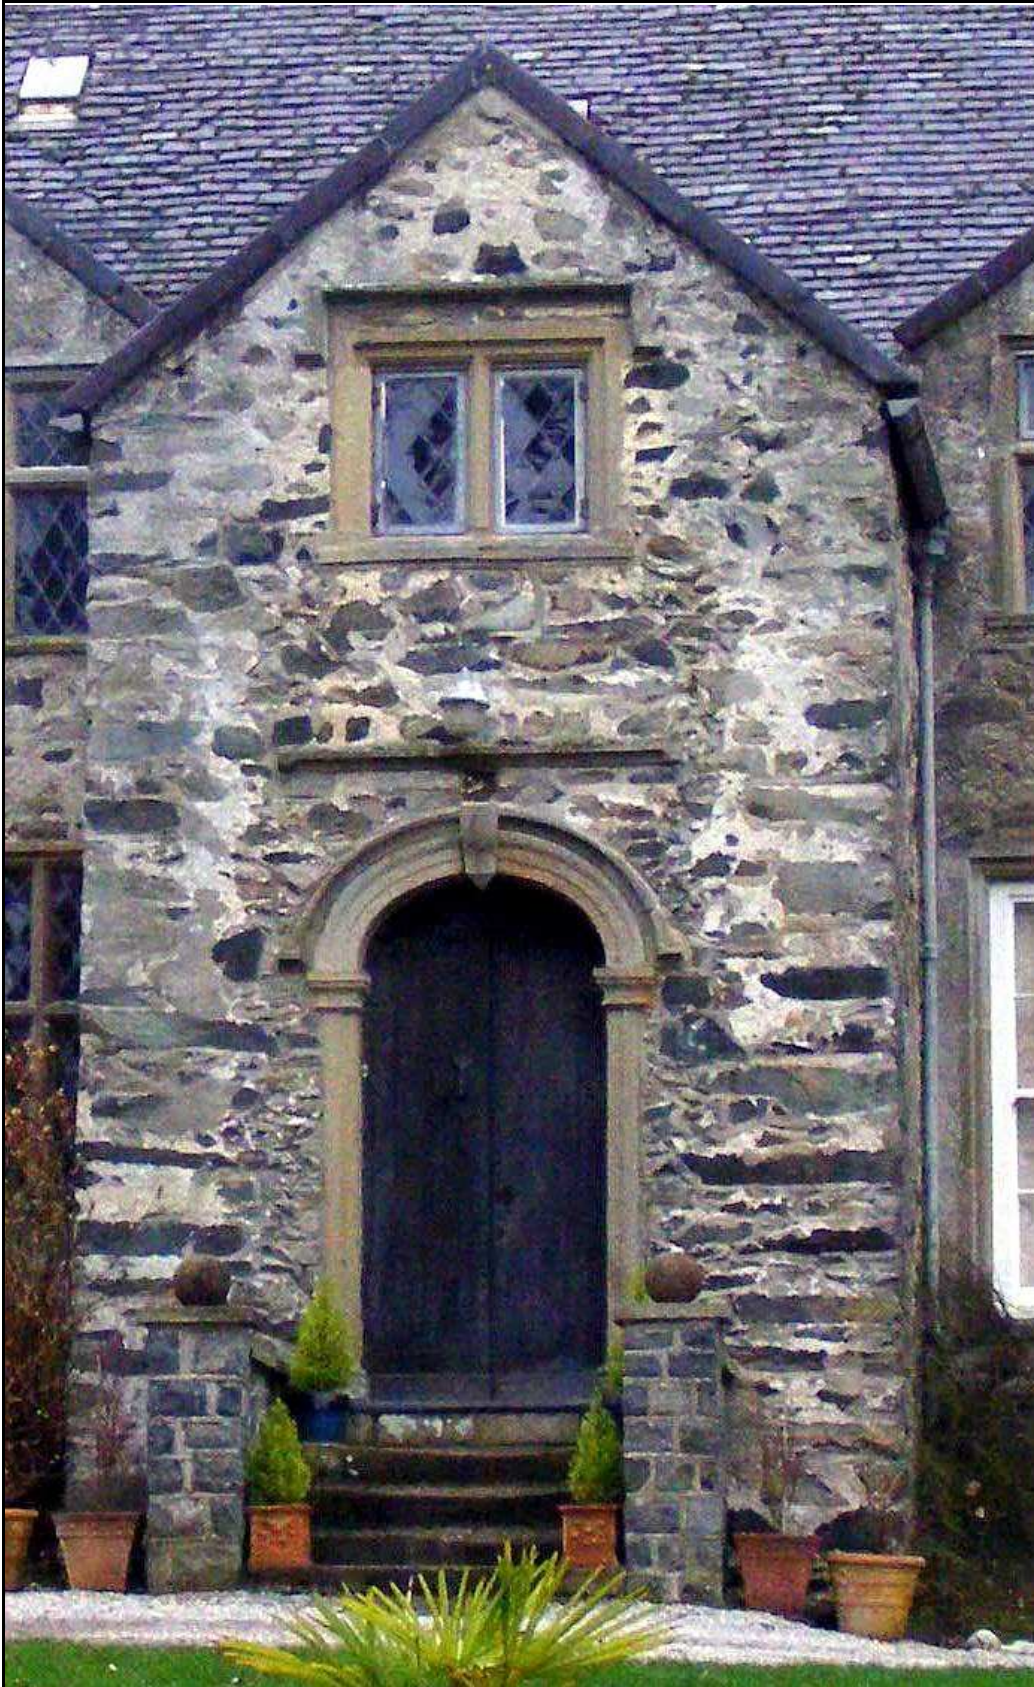
**Figure 56**, The entrance to the porch (P). Notice the change in masonry style between the phase 2 quoins and the tertiary insertion of the doorway and its string course above. The masonry above the window looks similar to that in the phase 1 side walls.

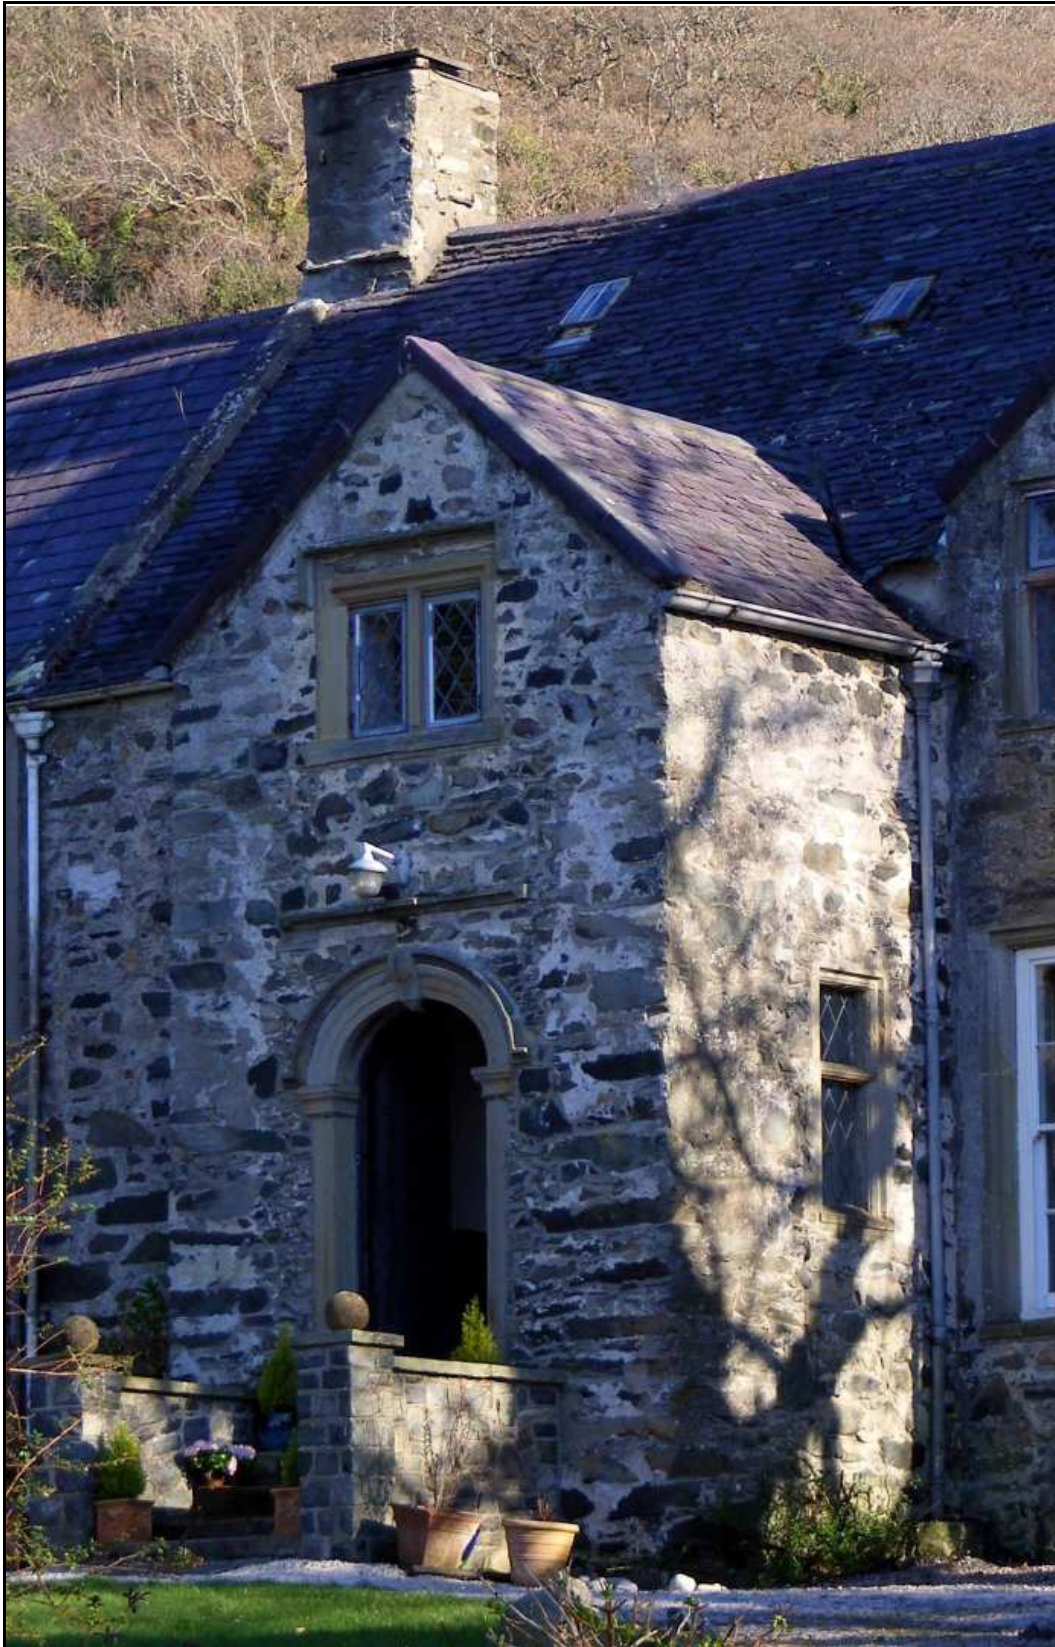
**Figure 60**, The porch (P) showing the different roof lines between this building and the main house (H).

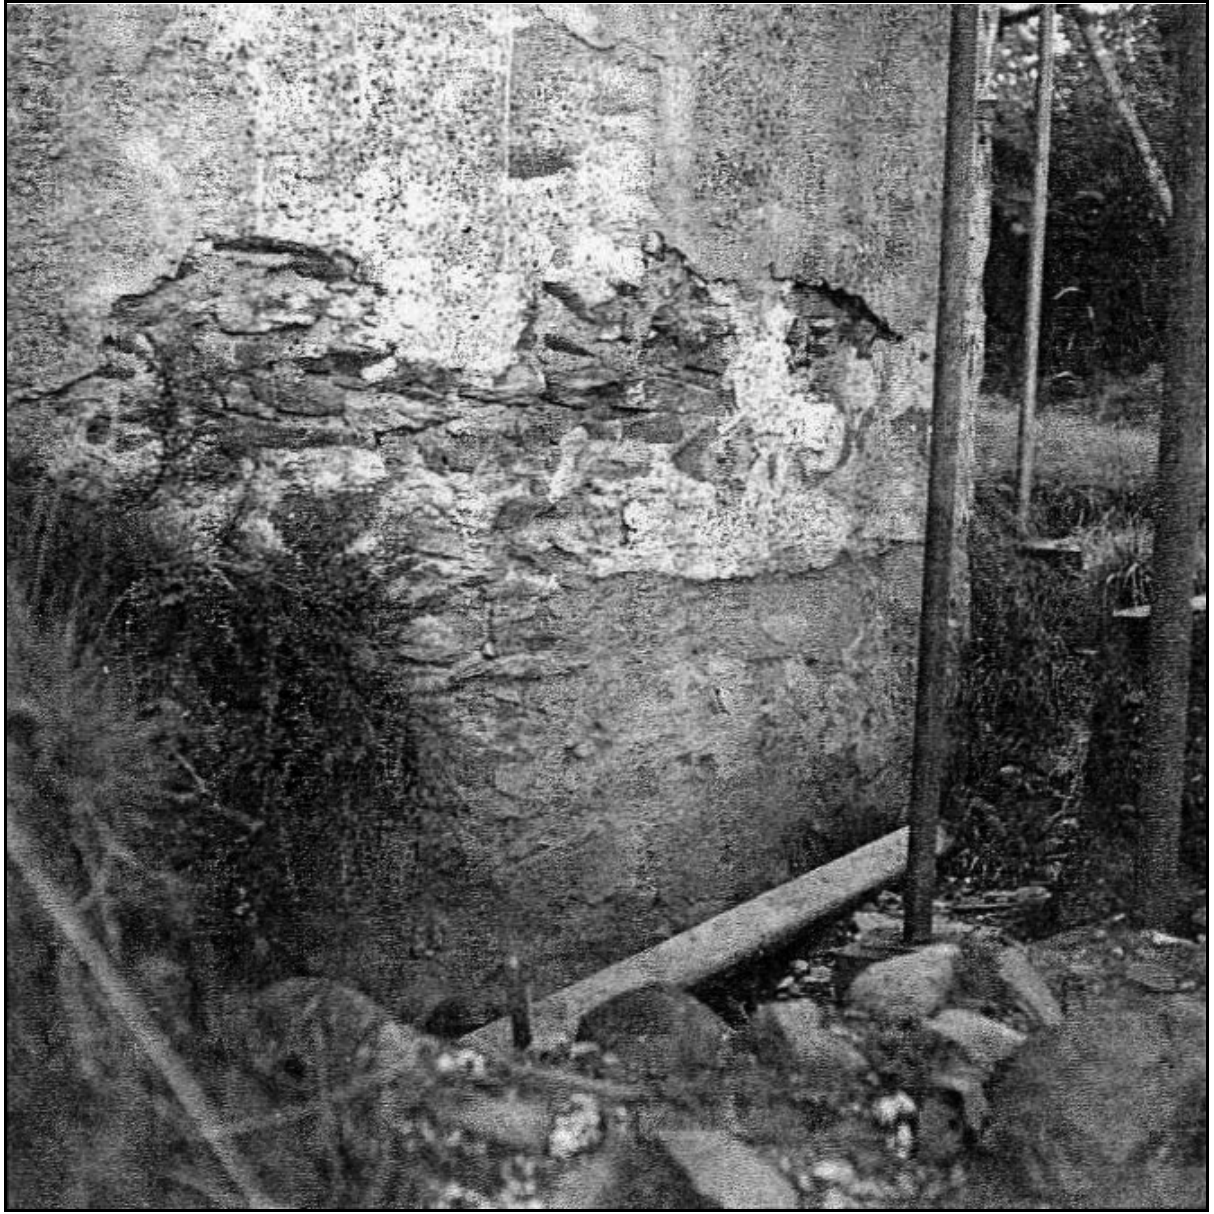
**Figure 64**, A buried portion of the tower (T) when uncovered during the excavations of 1993.

It is uncertain how deep the foundations of the tower go into the earth, or indeed if there even are any foundations, although the 1993 excavators seem to have dug down some four feet without reaching the base of the tower (Fig.64). It seems likely that the tower has a basement on the same level as the basement (B) as the stone steps down under the house (H) seem to pass through the masonry of this structure down to within a couple of feet of the current floor level of the basement (B). In other words the medieval ground seems to be about five feet beneath the current surface. There is nothing that can be usefully said about this portion of the tower except that it is about seventeen feet in external diameter. By comparison the solid half round turret at Degannwy castle is about the same size (Fig.65) as too are the wall towers of Whittington castle barbican which can be dated to between 1226 and 1240 (Fig.66)<sup>\*5</sup>.

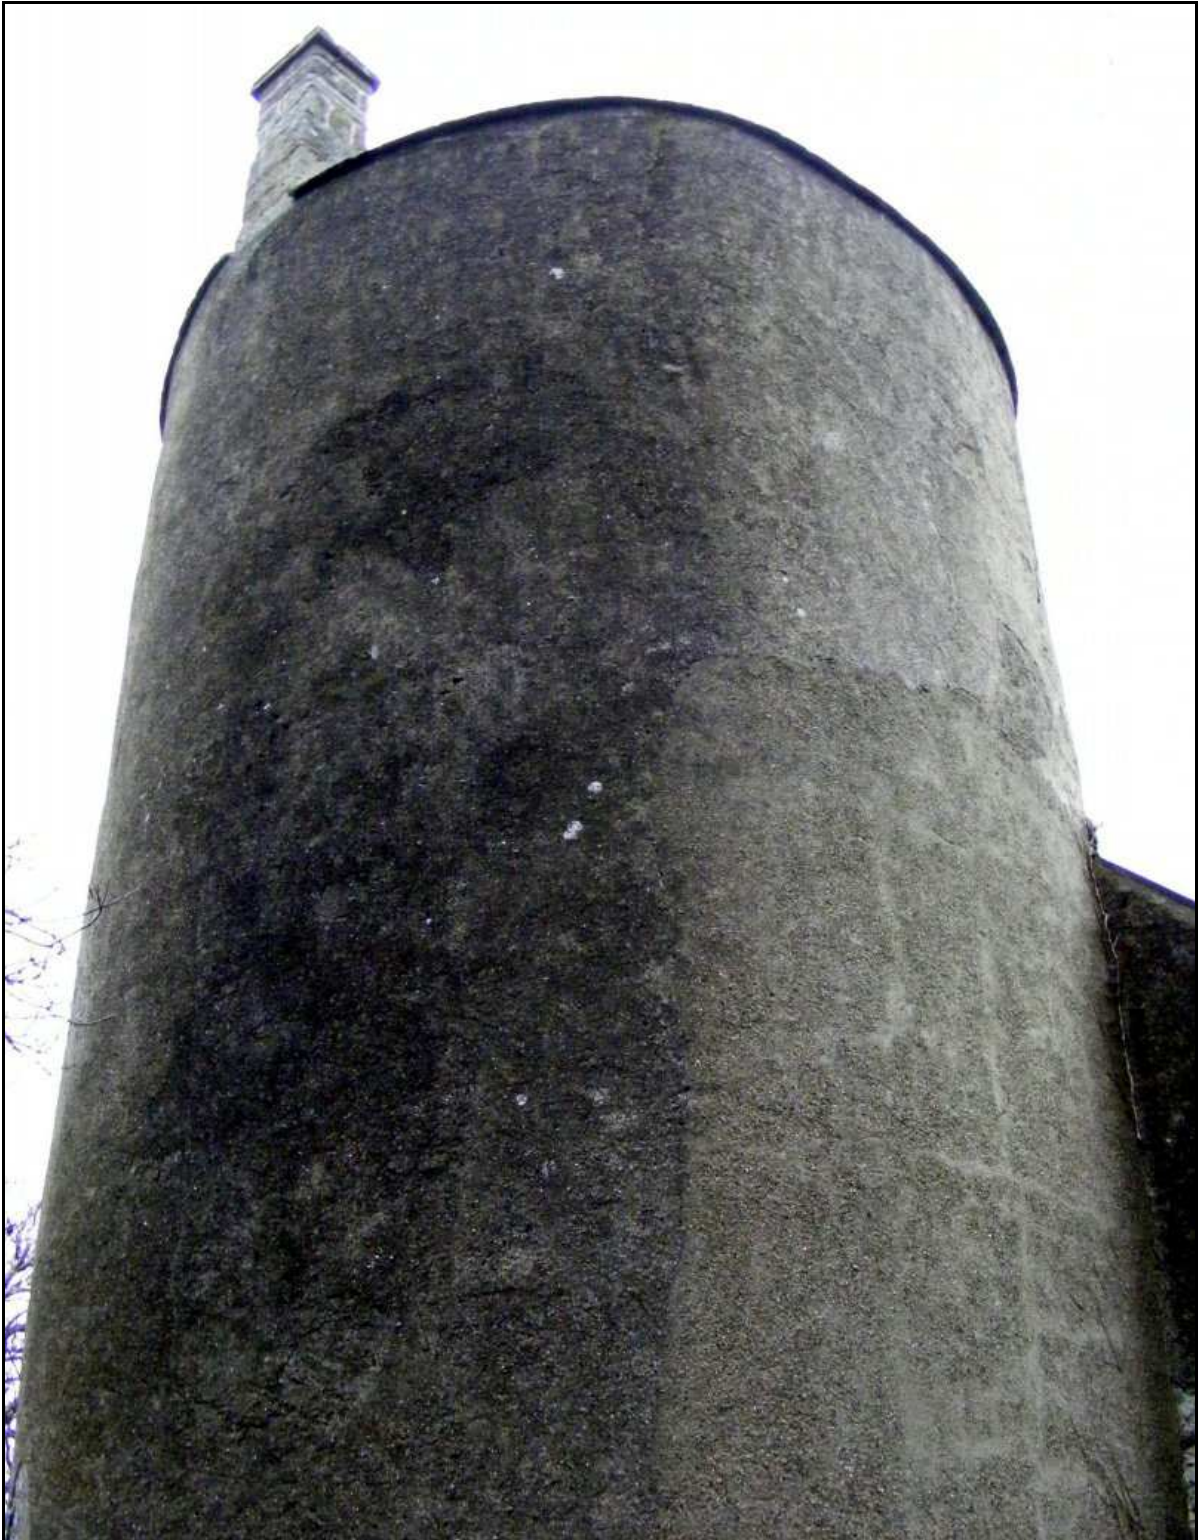
**Figure 67**, The western face of the tower (T) showing a rectangular depression on the third floor. An original window here to overlook the town is a distinct possibility.

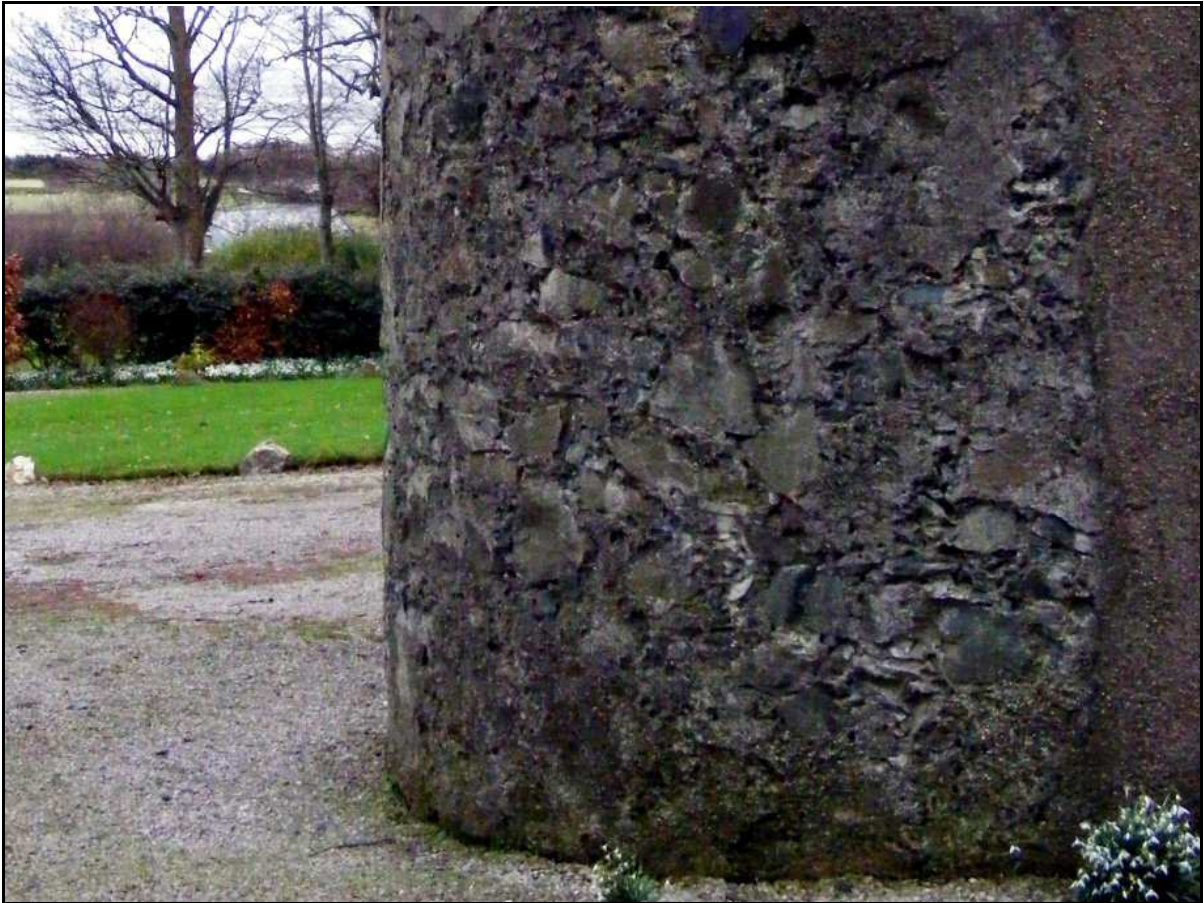
**Figure 68**, The base of the tower (T) showing the distinctively irregular make up of the masonry.

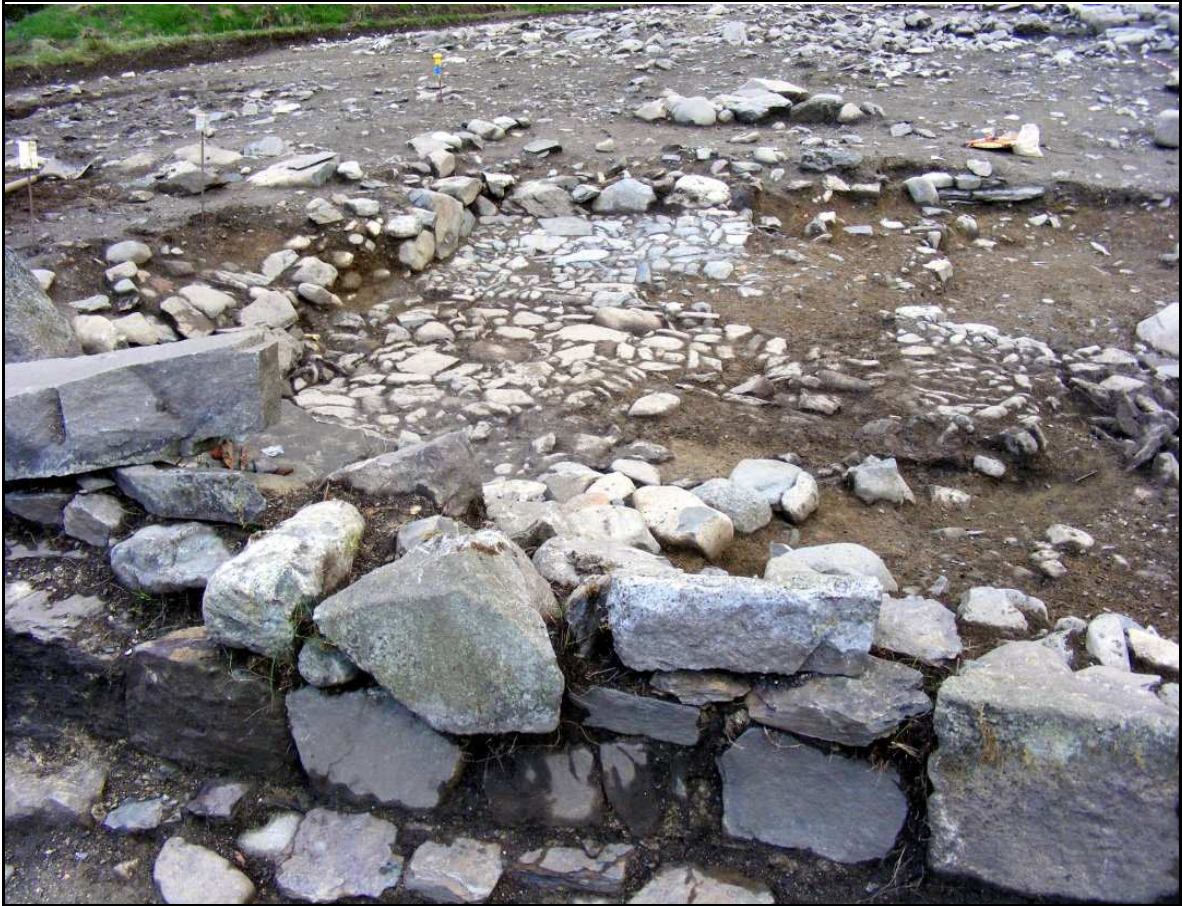
**Figure 75**, The poor remains of the mortar set in the 'north curtain' in Aber castle bailey with the cobbled floor of the 'north wing' beyond.

What we certainly have in the southern castle bailey are the remains of what is probably a series of structures quite unlike those excavated at Rhosyr and apparently unlike any of the remains found at other houses of the thirteenth and fourteenth century. Indeed the only 'Caernarfonshire halls of the fourteenth century' which looked even remotely like the Aber bailey site was a debatable reconstruction plan of Penrhyn. Other sites will be looked at under their own chapters later. The current walls within the southern bailey of Aber castle stand no more than a course or two high and show no sign of mortar other than poor leached remains seen to the north (Fig.75). What we are left with would not appear to be a 'high

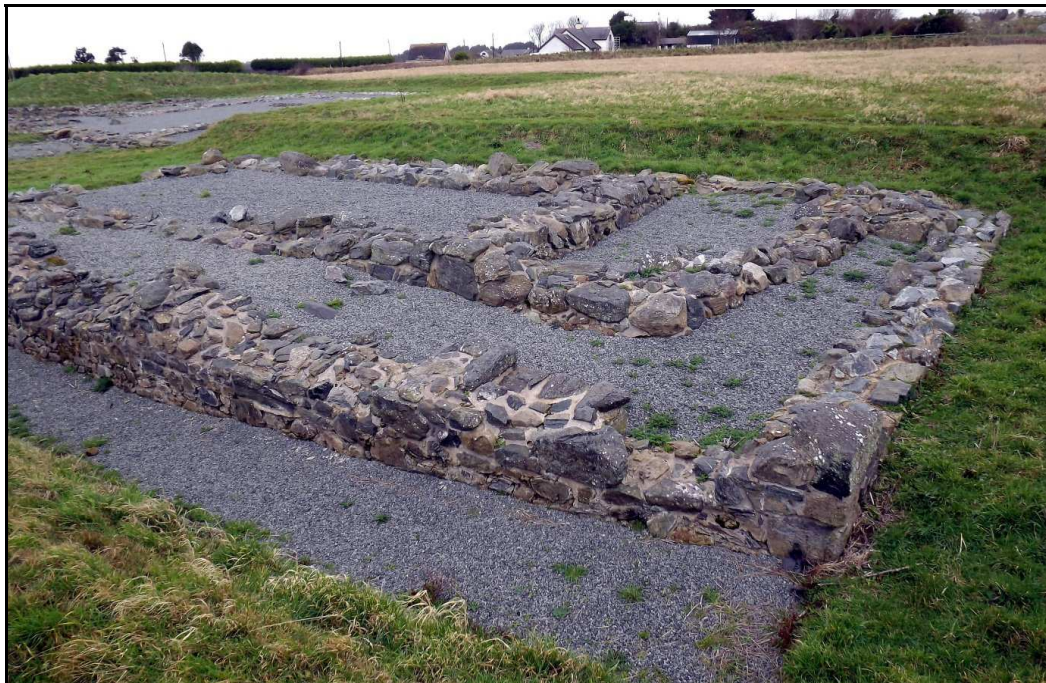
**Figure 77**, The rounded north-eastern end of the building B at Rhosyr. The dog-legged passageway can be seen beyond.

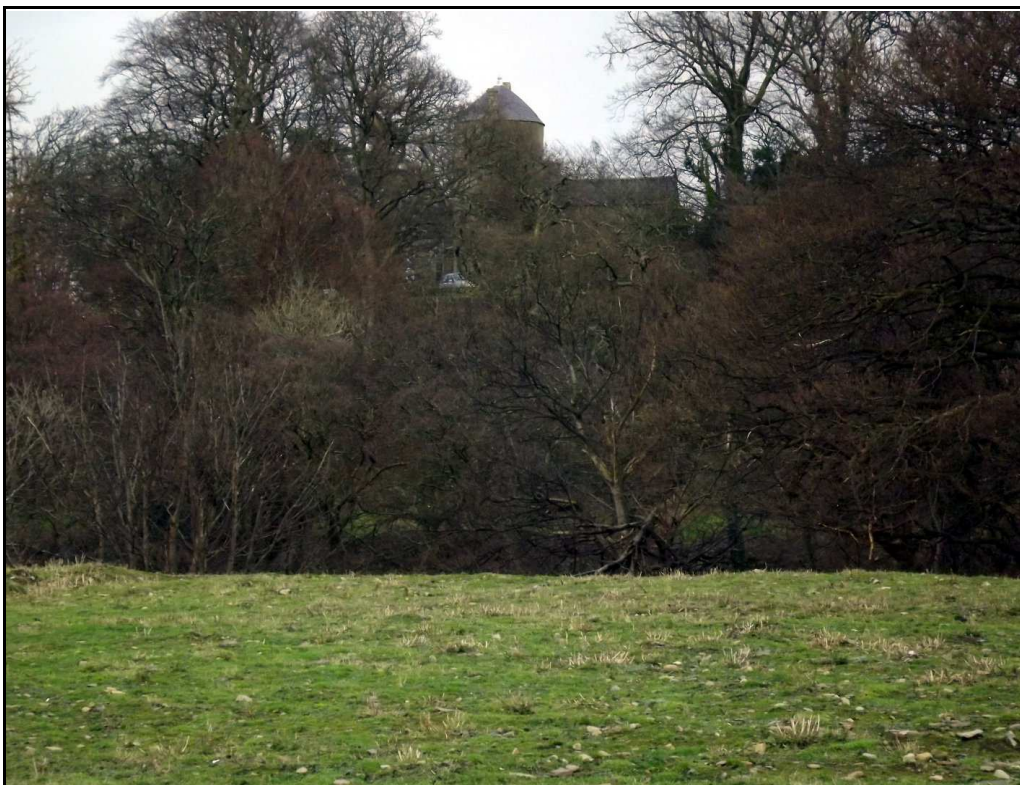
**Figure 82**, The tower (T) and south range (S) of Pen y Bryn from the recently recovered excavation site on the bailey of Aber castle.

Carlyle was obviously of the opinion that the Mwd was a burial mound and not a castle motte. His 'small portion of old building... pointed out near this mound' could as easily be in the castle bailey as up at Pen y Bryn overlooking the mound (Fig.82). The last statement that Llywelyn ab Iorwerth was the last prince to reside there is again palpable nonsense.

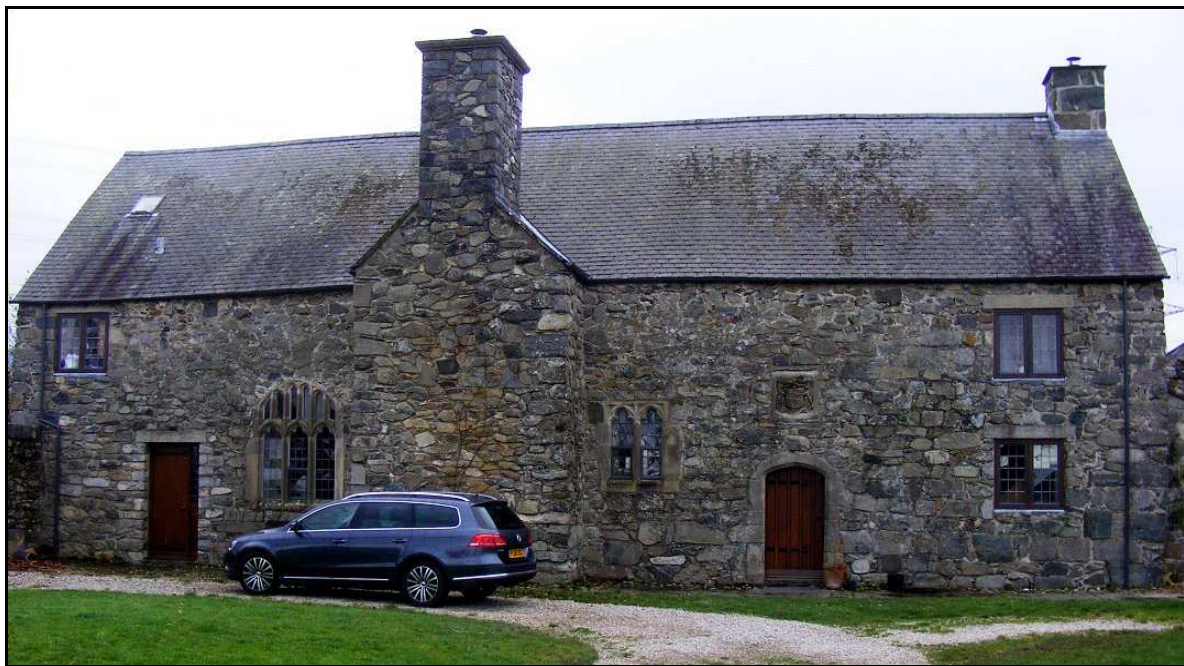
**Figure 83**, Cochwillan from the north showing the multiple building phases and inserted fenestration.

The current house suggests at least three different building phases and probably more. This can be ascertained from the different forms of masonry used (Fig.83). The first structure was possibly a hall about 37 feet by 21 with a large fireplace possibly added in the north wall. The walls were about three feet thick. This structure was apparently later rebuilt on the south front and then extended to east and west. Portions of the west wall are shown to date from this first build in the RCAHM report, but this is far from certain and the north-west corner appears more likely to be of a roughly sixteenth century date with its large cut stones which are quite different from the earlier rubble of the main walls.

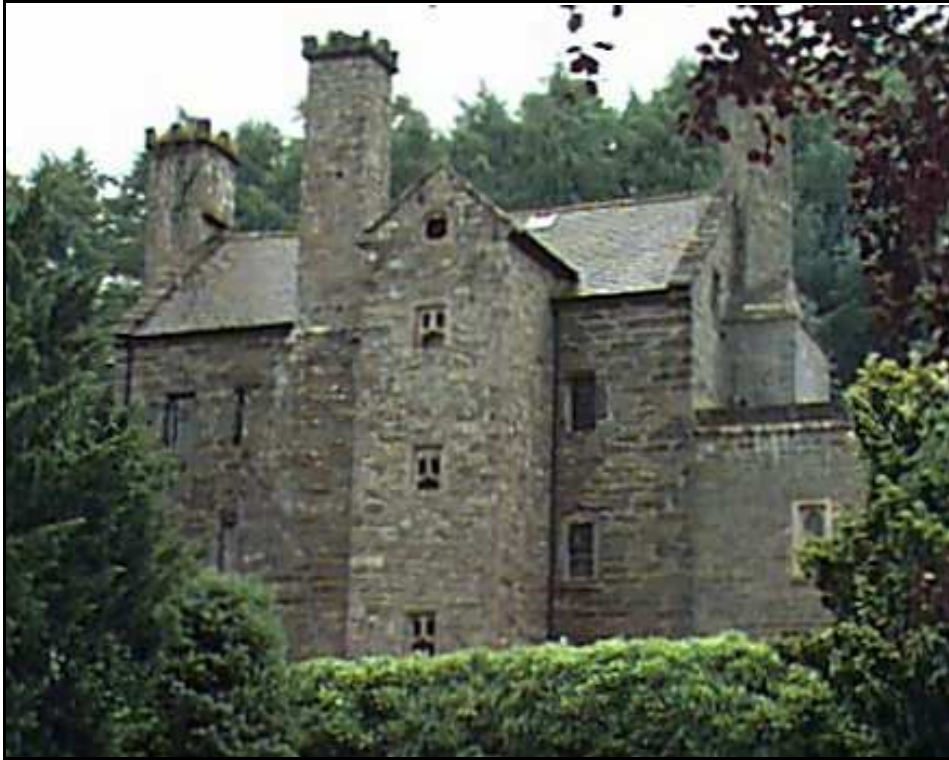
**Figure 85**, The early sixteenth century block at Gwydir from the north. Notice the 'mid sixteenth century' stair turret in the foreground which bares comparison to the porch (P) as it appeared in the Colt Hoare picture (Fig.22).

The early block is of four storeys and has an added northern stair turret and southern porch (Fig.85). This block has been much altered and rebuilt, but the eastern ground floor light in the south wall may be original (Fig.86). Certainly it once contained an iron grill for protection of the inhabitants from intruders. The south door may also be original. Certainly the construction of the building corners with quoins appears somewhat reminiscent of the rebuilt east end of the east range (E) at Pen y Bryn (Fig.32) although the masonry in general at Gwydir is far superior and better laid.

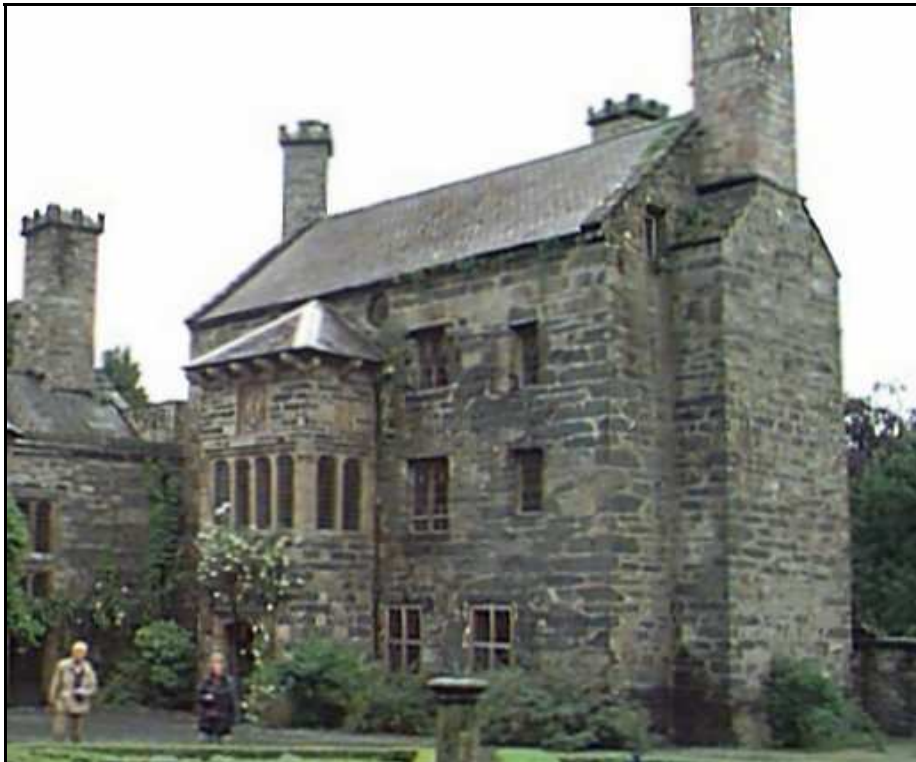
**Figure 86**, Gwydir from the south. The 'early' window is to the bottom right.
